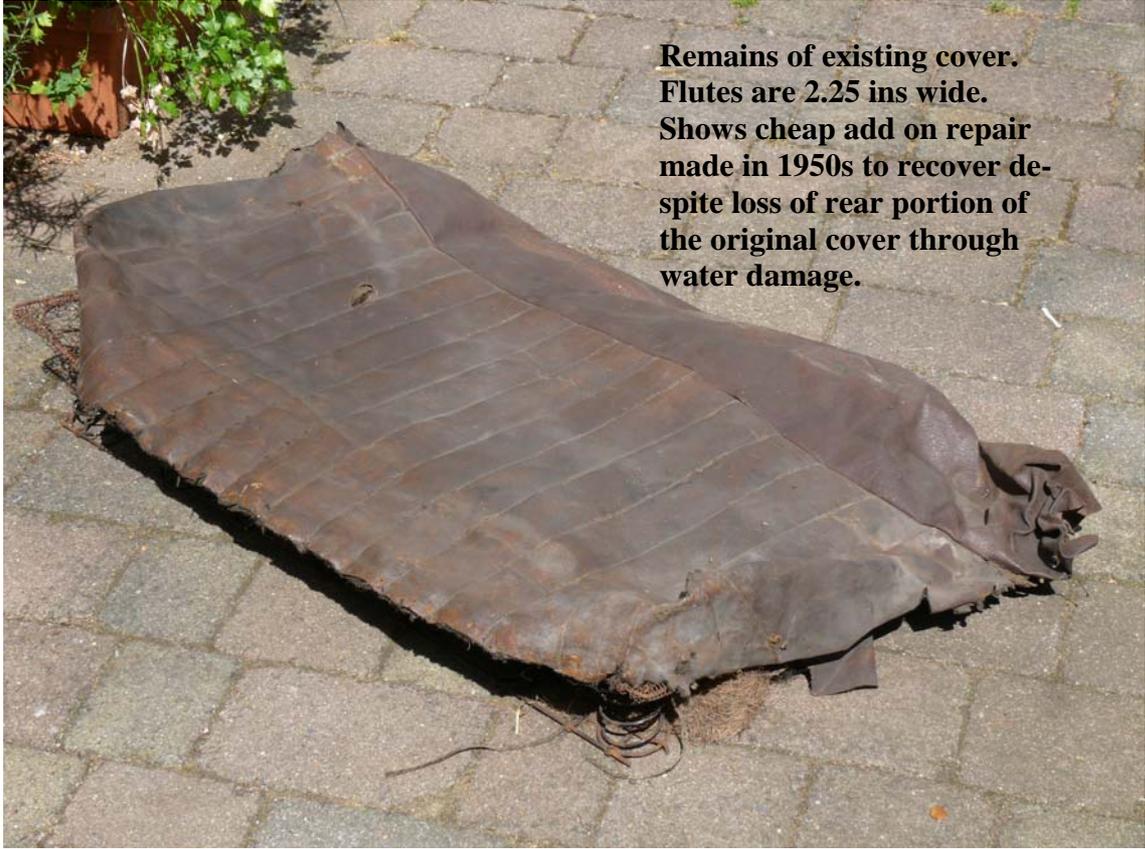
Remains of existing cover.
Flutes are 2.25 ins wide.
Shows cheap add on repair
made in 1950s to recover de-
spite loss of rear portion of
the original cover through
water damage.

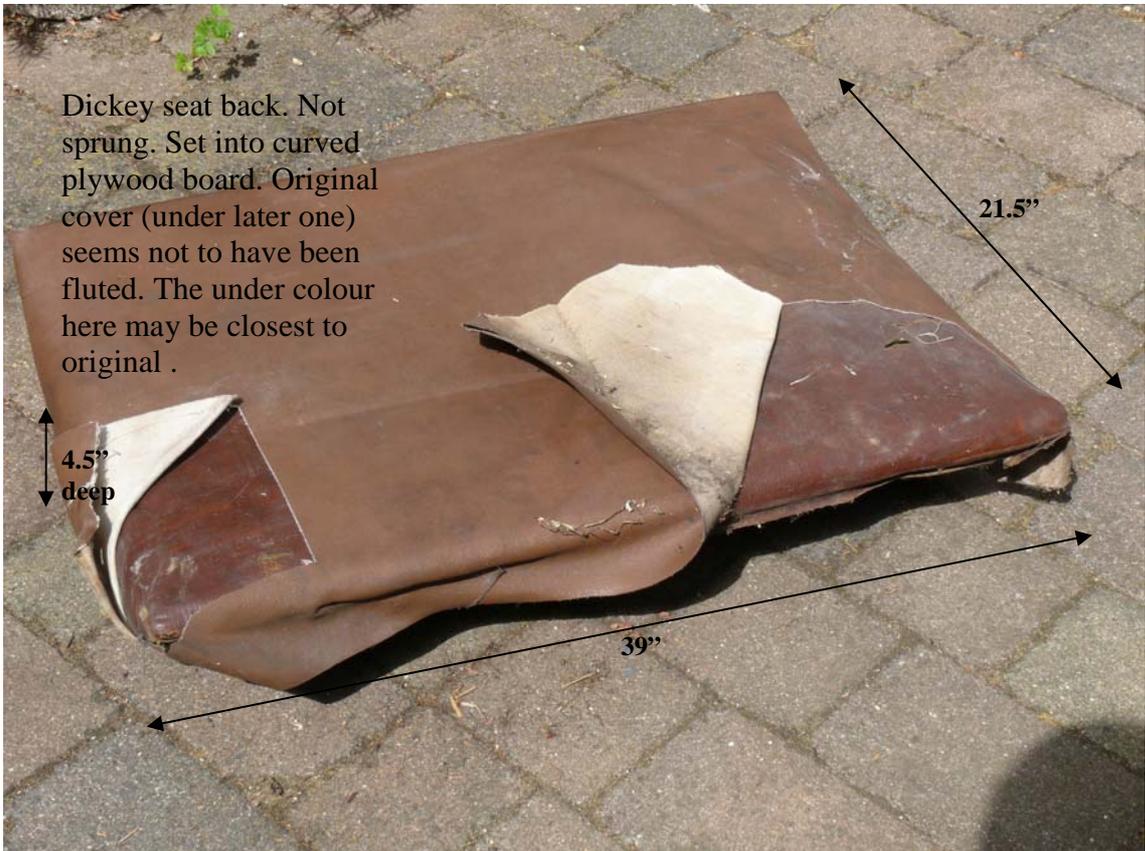
Dickey seat back. Not
sprung. Set into curved
plywood board. Original
cover (under later one)
seems not to have been
fluted. The under colour
here may be closest to
original .
